Exploring the Condition of Rental Housing in Spryfield, Nova Scotia

Dalhousie University, School of Planning

Plan 6000 Master's research project

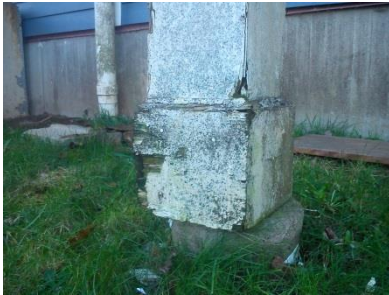
Figure 7: Deteriorated awning support

Murphy’s 2006 report on *The Viability of Converting Public Housing Projects to Tenant-Managed Housing in Spryfield* described the housing in Greystone as “in various states of disrepair, inside and out” (Murphy, p. 3) and repeatedly mentioned vandalism as a major concern in the area. However, my observations suggest that conditions have changed substantially since then; Greystone had little evidence of vandalism compared to the private rental housing elsewhere in Spryfield, and although some common areas in Greystone were covered in litter, most individual units appeared well-kept and showed few exterior signs of deterioration. Signs of deterioration that I observed were mostly limited to rusted handrails and deterioration of the larger, pre-2010 awnings.

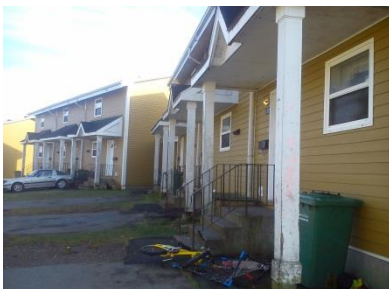
Figure 8: Old Greystone awnings

The buildings within the Greystone public housing project generally showed few signs of deterioration, likely due to a major refurbishment initiative that began in 2010. The majority of these buildings had iron railings with a conspicuous amount of rust; this was by far the most common sign of deterioration observed. Some of the buildings had large awnings supported by wooden posts; all of these awnings showed signs of deterioration. However, renovations are still in progress and it appears that these awnings are being replaced by smaller, cantilevered awnings, which lack most of the features of the older awnings that are particularly prone to deterioration. Most of the properties appeared “lived-in” but well-kept – lawns were well-maintained and, in contrast to Murphy’s 2006 report, graffiti was uncommon. The areas that showed the most neglect were actually the wide-open areas of unprogrammed public space, which were in many cases covered in litter. This could potentially be attributed to a general lack of public garbage cans in the area along with windy conditions on the exposed hillside. The building at 110 Lyons Avenue, which is also managed by the MRHA, has also recently been renovated and did not show any signs of deterioration.

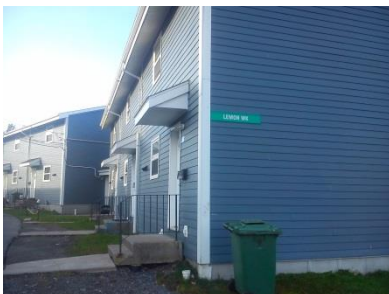
Figure 9: New Greystone awnings

Greystone has recently benefitted from joint federal-provincial funding which provided Halifax-area affordable housing projects with \$14 million in upgrades and repairs; \$5.9 million of this went to Greystone, and upgrades included new siding, roofs, doors, and windows, as well as upgrades to kitchen equipment, electrical, plumbing, and fire safety systems, and increased the energy efficiency of the buildings (Taplin 2010). Because rents in Greystone are geared to income, rents cannot increase as a result of upgrades. This stands in sharp contrast to the 500 block, where rents are said to have increased following even marginal improvements to the buildings.

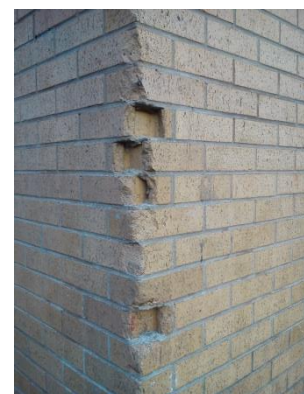
Surprisingly, with the privately owned buildings, there was little consistency in observed building conditions, either among buildings with a common owner, or buildings of the same basic typology. Even the parking areas of neighbouring buildings, managed by the same landlord, were often in very different conditions. Peeling paint, rust, damaged light fixtures, damaged siding, and graffiti or other forms of vandalism were the most frequently observed signs of deterioration. Of greater concern, perhaps, were multiple incidences of rotting wood and crumbling bricks. In the 500 Block of Herring Cove Road, 5 buildings had visibly

Figure 10: Deteriorating brick

deteriorating bricks or concrete. Five of 8 buildings in the 500 block also showed signs of vandalism such as graffiti. Vandalism was common on River Road, with 6 out of 13 buildings displaying graffiti. The exterior conditions within the cluster of privately-managed buildings on Lynnett, McIntosh and Autumn varied considerably between properties. Of the 8 properties I examined that showed five or more signs of deterioration, 4 are currently managed by MetCap, and none are part of the Greystone housing project.

In order to bring the privately-owned rental properties back up to standard, landlords should be encouraged to take advantage of the province’s Rental Residential Rehabilitation Assistance Program. The program should be better advertised, ideally as a grant-based rather than loan-based program, and “below market rent” needs to be defined. Additionally, the provincial government should consider offering rent supplements directly to low-income citizens, rather than directly supplementing specific rental units. Finally, the provincial government should consider funding a program to replace oil furnaces with a more cost-effective means of heating, particularly in aging low-rent apartment buildings.

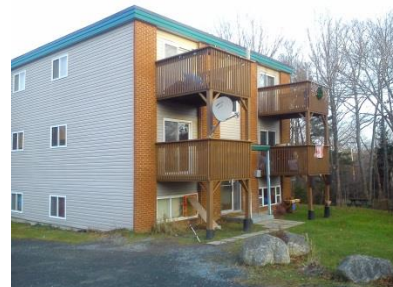
Many of the privately owned buildings had balconies which appeared to have been added after the buildings' initial construction. Though this does indicate a certain level of investment in the properties, most of these balconies were constructed of wooden posts, resting on concrete piles of

Figure 11: Added-on balconies

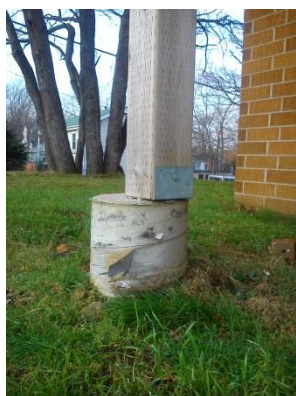
Figure 12: Safety hazard?

approximately two feet, driven into the ground – similar to the older, deteriorated awnings in Greystone. In some cases, it appeared as though the posts were not anchored properly, potentially creating a safety hazard.

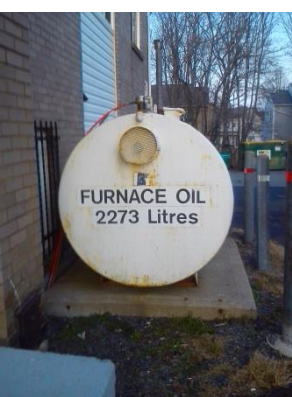
Although utilities were outside the scope of my research, I did notice that many of the buildings are heated by oil. Oil furnaces are among the most expensive ways of heating a building (Government of Canada 2014) and because furnaces heat all units in a building with no way of differentiating between units, the cost of fuel is typically borne by the

landlord. The high cost of heating may be a contributing factor in landlords' inability or unwillingness to focus on maintenance issues, because it reduces their profit margins.

Figure 13: Evidence of oil heating

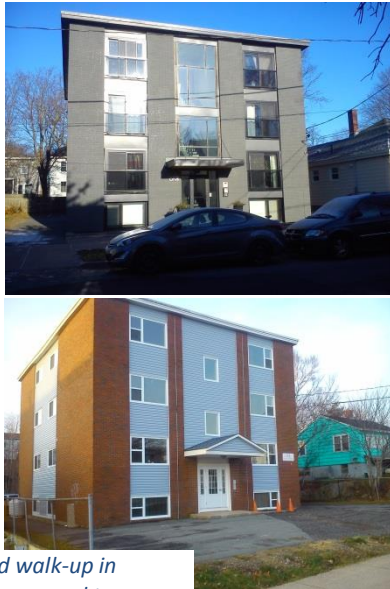
Figure 14: Renovated walk-up in Halifax's West End compared to a similar building in Spryfield

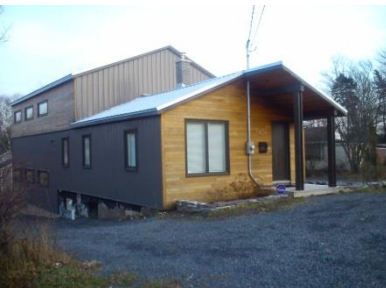
Figure 15: Recently renovated house on Herring Cove Road
